## HEYSEL METRO STATION

Brussels • Belgium

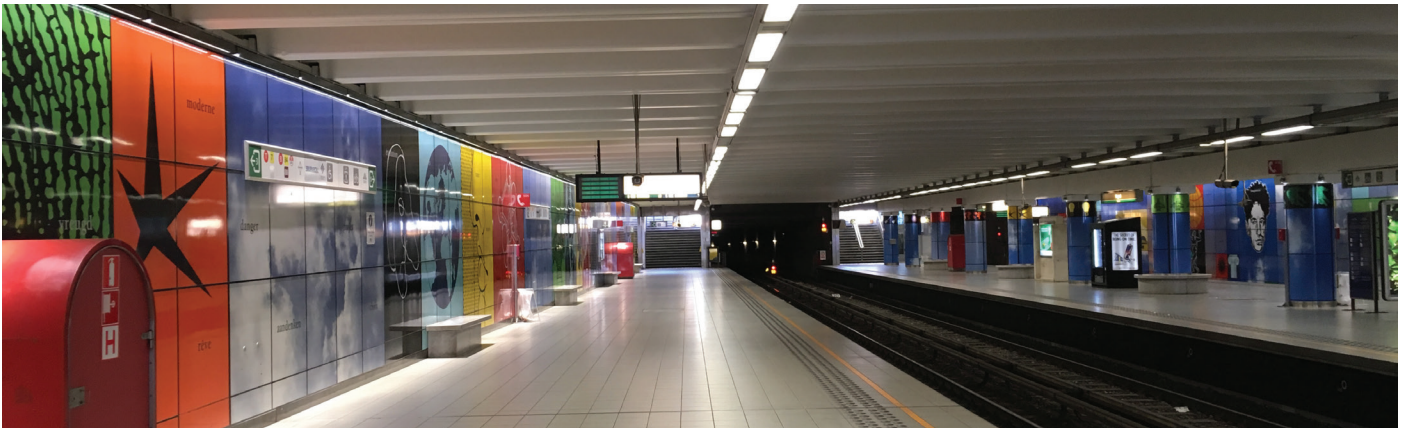
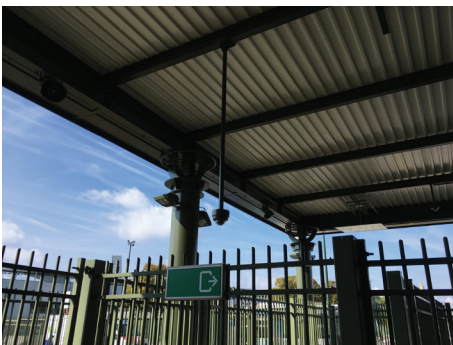
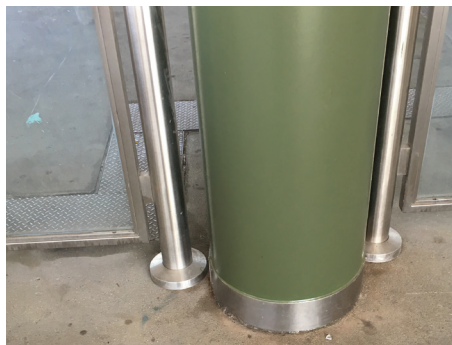
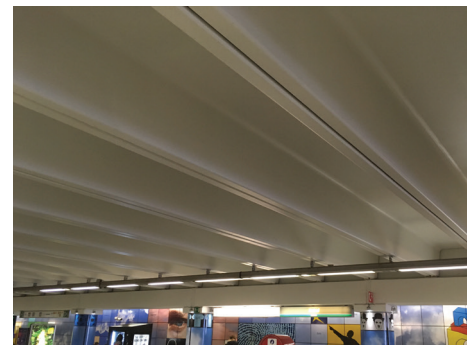
Renovation of 64 Brussels subway stations requiring night work. Concrete and steel structures. Very dusty and greasy surfaces due to the air displacement of the passage of the metro trains. Walls covered by tags and graffiti. The high humidity level in the subground metro stations causes the formation of rust on the steel structures.

- A preliminary study and high-performance R & D laboratory tests have enabled the company Belcolor to undertake painting work under the best conditions thanks to the Libert paint system:
- On not painted concrete: **Aquafix/Hydroprim/Acrylon** (2 coats).
- On already painted concrete: **Hydroprim/Acrylon** (2 coats).
- On steel: **Polyfix/Cryltane DTS 20** in a RAL colour.
